AIR INFILTRATION: THE ENEMY OF *WIND RESISTANCE* AND **CONDENSATION CONTROL**

By Philip Dregger, PE, RRC

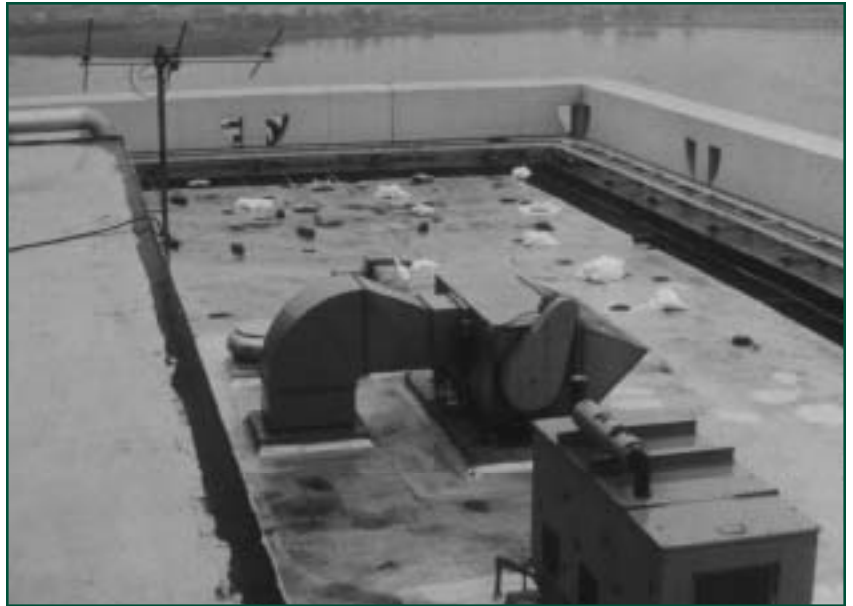
Figure 5 shows a twelve-story office building with a smooth-surfaced BUR that experienced wind damage at wind speeds well below design levels. The BUR included a fiberglass base sheet fastened into lightweight insulating concrete (LWIC) over a structural concrete deck – an assembly typically viewed as "impermeable" to air infiltration. Investigation indicated a pathway for rapid air infiltration around the impermeable deck and into the space between the base sheet and LWIC. Relatively high-pressure interior air could flow up through stud spaces within EIFS-clad parapet walls, behind the wood fiber cant strips, and below the base sheet. Upward and outward movements of base flashings initiated progressive peel of the membrane. Base sheet deterioration contributed to the damage conditions.

Figure 5: A twelve-story office building that experienced wind damage at wind speeds well below design levels

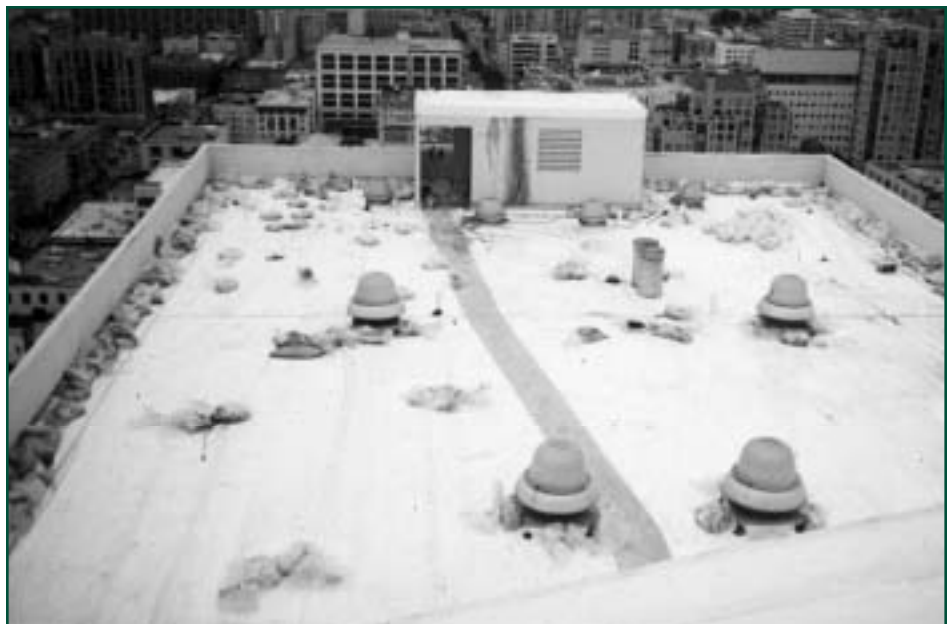
Figure 6 shows a fourteen-story building with 4' parapet walls and a concrete roof deck. The fully-adhered, felt-back PVC membrane experienced wind damage shortly after installation. The system carried an FM 1-90 rating. Openings for air infiltration around the edges of the concrete deck were present in the stud spaces of stucco-clad parapet walls. Membrane base flashings did not include a termination bar at roof level – only along the top of base flashings. Air infiltration from below is believed to have billowed membrane base flashings outward and initiated progressive peel of membrane – a scenario consistent with eyewitness observations. Other non-air infiltration related conditions contributed to this example of damages at wind speeds well below design levels.

Figure 6: A fourteen-story building with a concrete deck and a fully-adhered, felt-back PVC membrane surrounded by 4' parapet walls that experienced wind damage shortly after installation.
