CONCRETE CORROSION - RESTORATION - REPAIR

by Lewis Ng, P.E. & Philip Dregger, P.E. - Twin City Testing Corporation

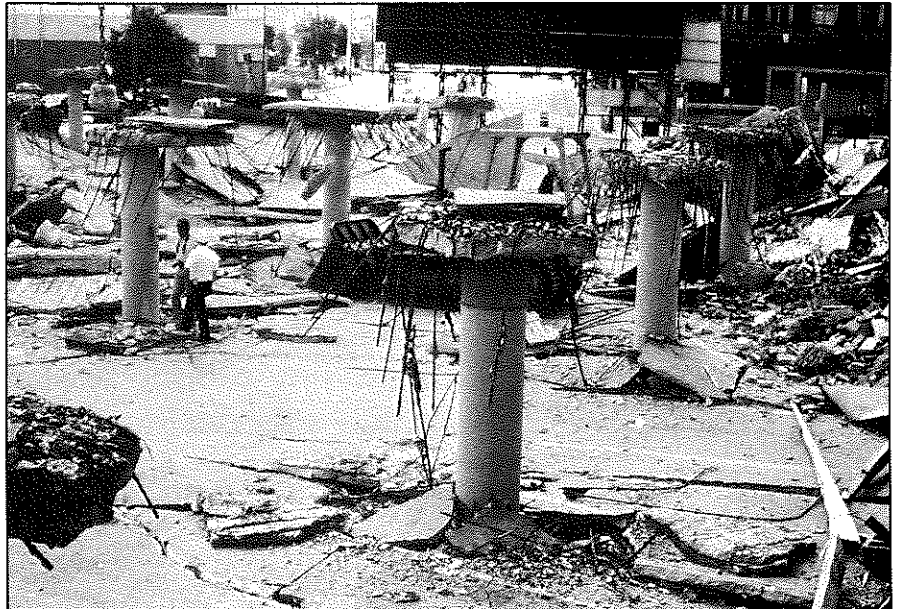
A parking structure which collapsed due to deterioration

Most parking structures built before 1980 were not adequately protected against corrosion and have not been adequately maintained. As a result, significant deterioration can be seen in almost every northern climate parking structure. Careful evaluation, design and maintenance
